Your Inspection Report

29 Abbott Ave
Toronto, ON

Tuesday, February 16, 2010

RE: Report No. 20442, v.2
29 Abbott Ave
Toronto, ON

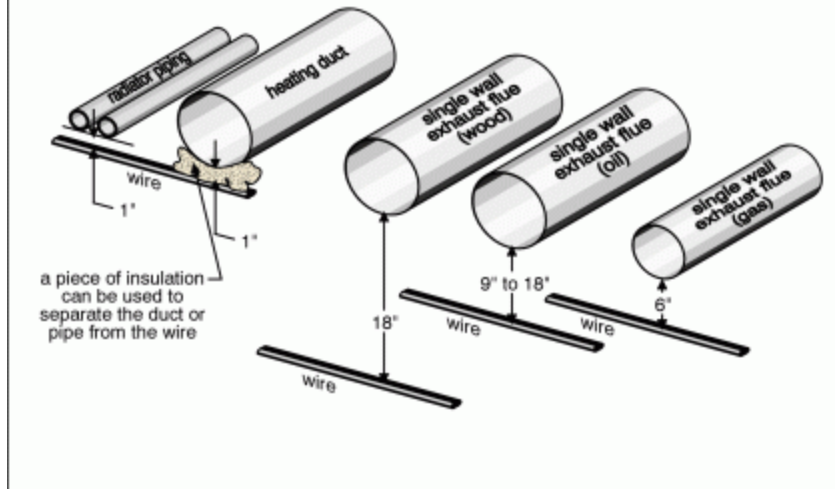
Condition: • [Ducts/piping touching wire](#)

Location: Basement Furnace Room

Wire clearances from hot ducts and pipes

Task: Correct

Time: Immediate
